**DEPARTMENT OF TRANSPORTATION****DIVISION OF ENGINEERING SERVICES**

Contract #: 04-0120F4Cty: SF/ALA Rte: 80 PM: 13.2/13.9File #: 69.28**WELDING INSPECTION REPORT****Resident Engineer:**Pursell, Gary**Address:** 333 Burma Road**City:** Oakland, CA 94607**Report No:** WIR-007117**Date Inspected:** 08-May-2009**Project Name:** SAS Superstructure**OSM Arrival Time:** 1900**Prime Contractor:** American Bridge/Fluor Enterprises, a JV**OSM Departure Time:** 700**Contractor:** Zhenhua Port Machinery Company, Ltd (ZPMC), Changxing Island **Location:** Shanghai, China**CWI Name:** See Below**CWI Present:** Yes No**Inspected CWI report:** Yes No N/A**Rod Oven in Use:** Yes No N/A**Electrode to specification:** Yes No N/A**Weld Procedures Followed:** Yes No N/A**Qualified Welders:** Yes No N/A**Verified Joint Fit-up:** Yes No N/A**Approved Drawings:** Yes No N/A**Approved WPS:** Yes No N/A**Delayed / Cancelled:** Yes No N/A**Bridge No:** 34-0006**Component:** OBG Fabrication**Summary of Items Observed:**

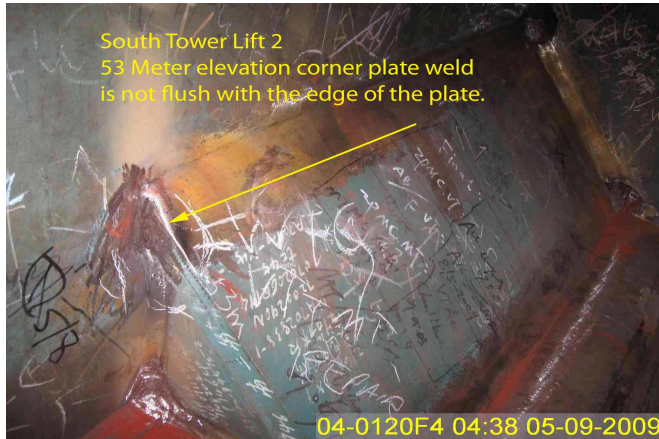
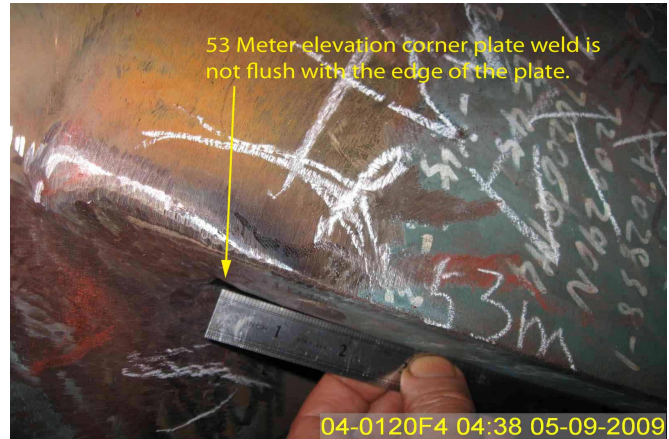
This QA Inspector along with other QA Inspectors performed random visual inspections of lift 2 corner plates inside South Tower Lift 2. The QA Inspector observed the 52 meter elevation corner plate has a below flush condition at the end of the weld. See the photograph below for additional information.
